L2010300009 – Winnebago
Rockford Sand and Gravel
ILO 000034371
SF/HRS

CERCLA EXPANDED SITE INSPECTION

ROCKFORD SAND & GRAVEL
ILO000034371

April 17, 2002

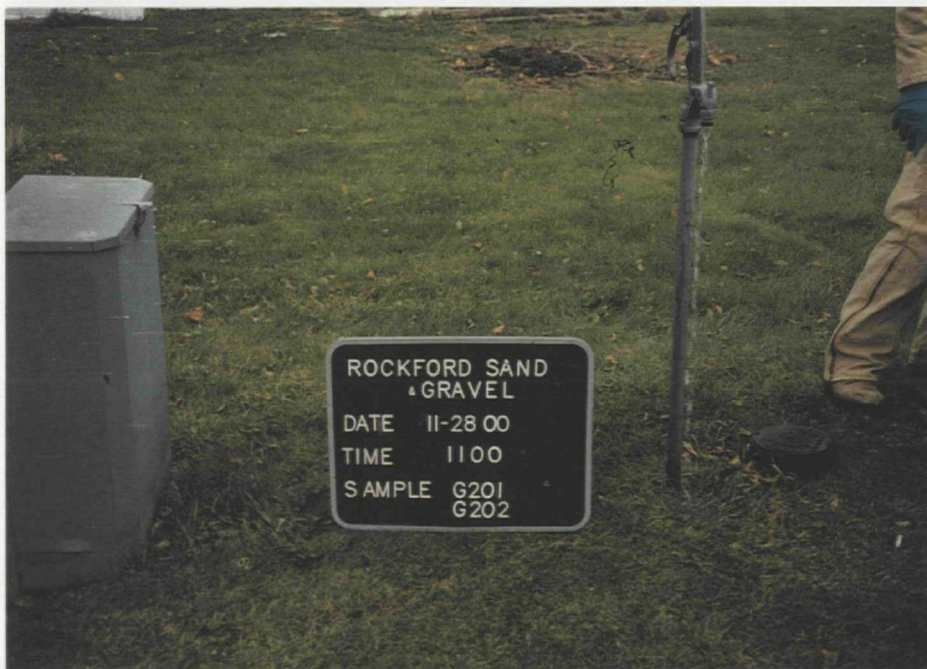
DATE: 11-28-2000	SITE ILO#: 000034371	COUNTY: Winnebago
TIME: 11:00	SITE NAME: Rockford Sand & Gravel	
PHOTOGRAPH TAKEN BY: R. Casper		
COMMENTS: Picture taken toward: East.		
Photo Number 1.		
Sample G201/G202.		
is a background		
and duplicate		
drinking water		
sample.

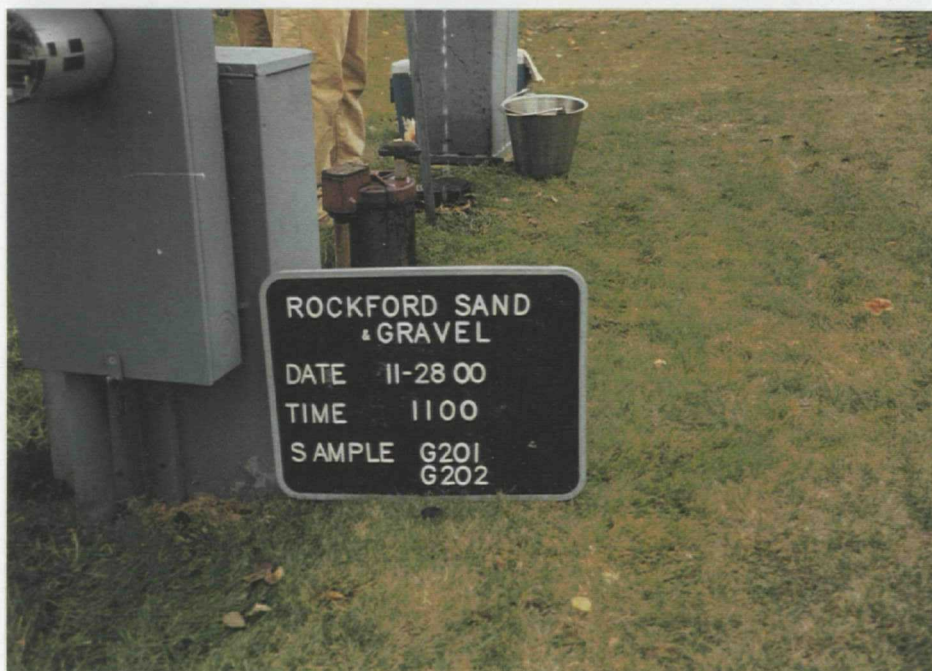
DATE: 11-28-2000
TIME: 11:00
PHOTOGRAPH TAKEN BY: R. CASPER
COMMENTS: Picture taken toward: South.
Photo Number 2.
Sample G201/G202.
The sample was
collected from an
87 feet deep well
at a trailer park
.8 mile south.

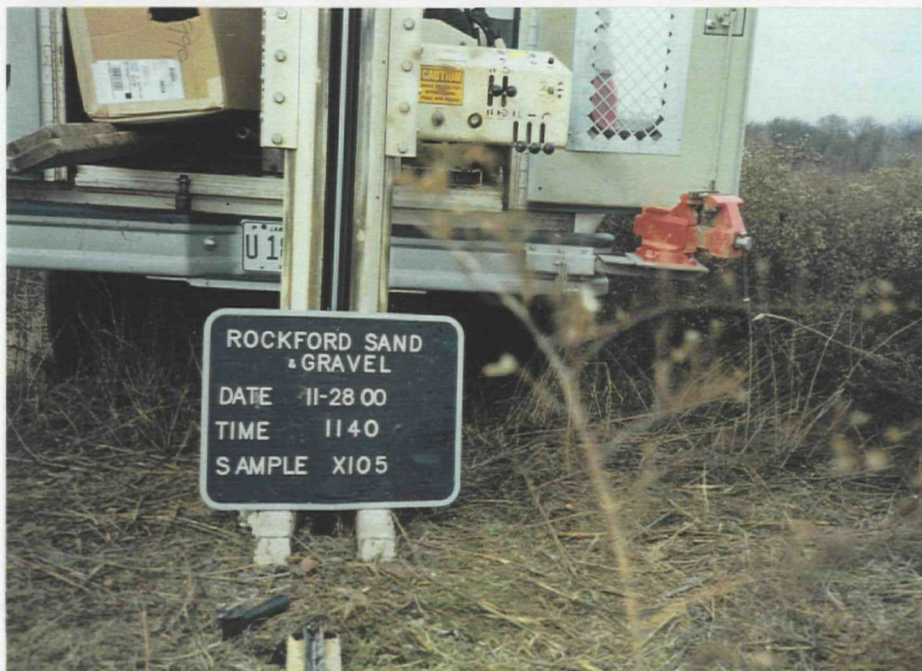
DATE: 11-28-2000	SITE ILO#: 000034371	COUNTY: Winnebago
TIME: 11:40	SITE NAME: Rockford Sand & Gravel	
PHOTOGRAPH TAKEN BY: R. Casper		
COMMENTS: Picture taken toward: West.		
Photo Number 3.		
Sample X105 was collected onsite in the southeast area of the property.

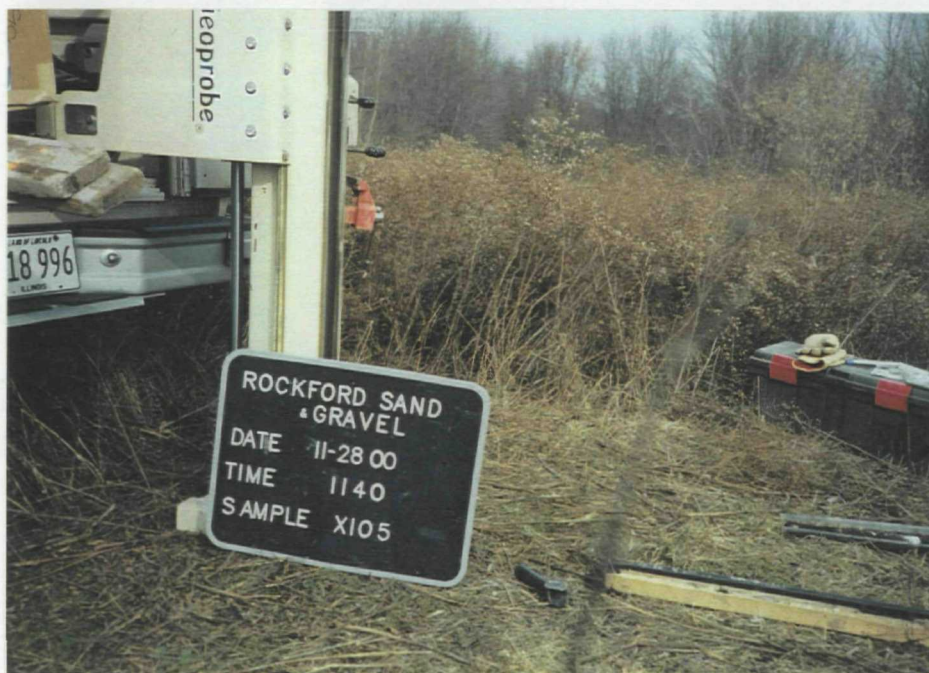
DATE: 11-28-2000
TIME: 10:40
PHOTOGRAPH TAKEN BY: R. CASPER
COMMENTS: Picture taken toward: North.
Photo Number 4.
Sample X105. The sample was collected with the Geo-Probe at a depth of 18 to 20 feet.

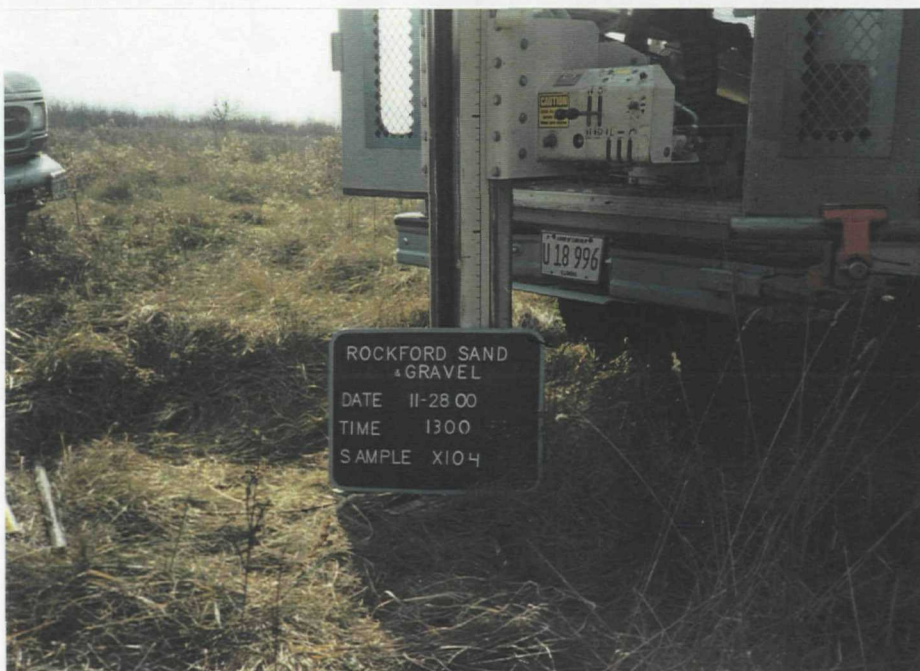
DATE: 11-28-2000	SITE ILO#: 000034371	COUNTY: Winnebago
TIME: 13:00	SITE NAME: Rockford Sand & Gravel	
PHOTOGRAPH TAKEN BY: R. Casper		
COMMENTS: Picture taken toward: West.		
Photo Number 5.		
Sample X104 was collected at the east-central area of the property.

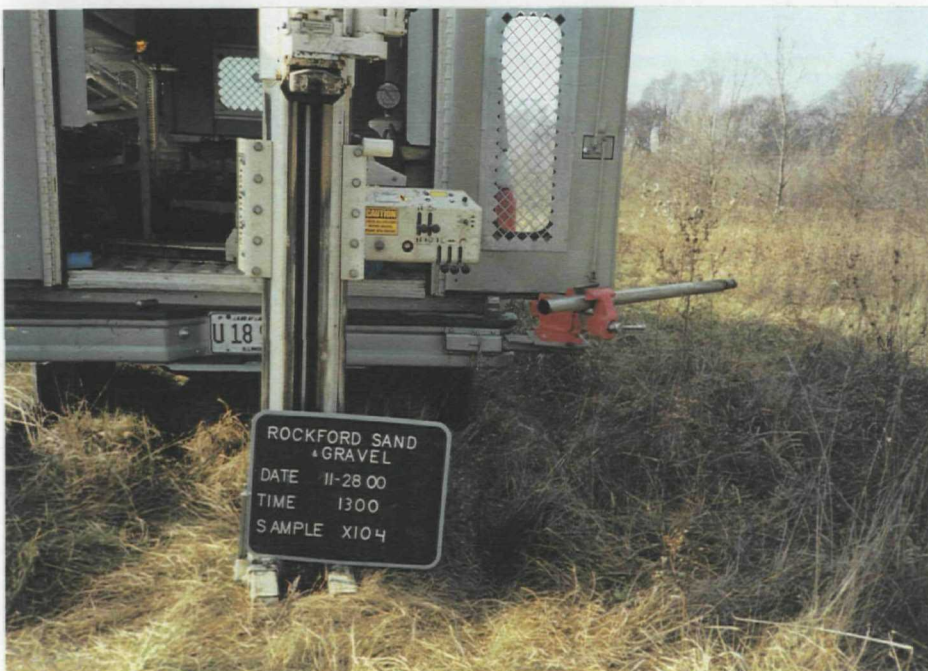
DATE: 11-28-2000
TIME: 13:00
PHOTOGRAPH TAKEN BY: R. CASPER
COMMENTS: Picture taken toward: North.
Photo Number 6.
Sample X104. The sample was collected with the Geo-Probe at a depth of 2 to 8 feet.

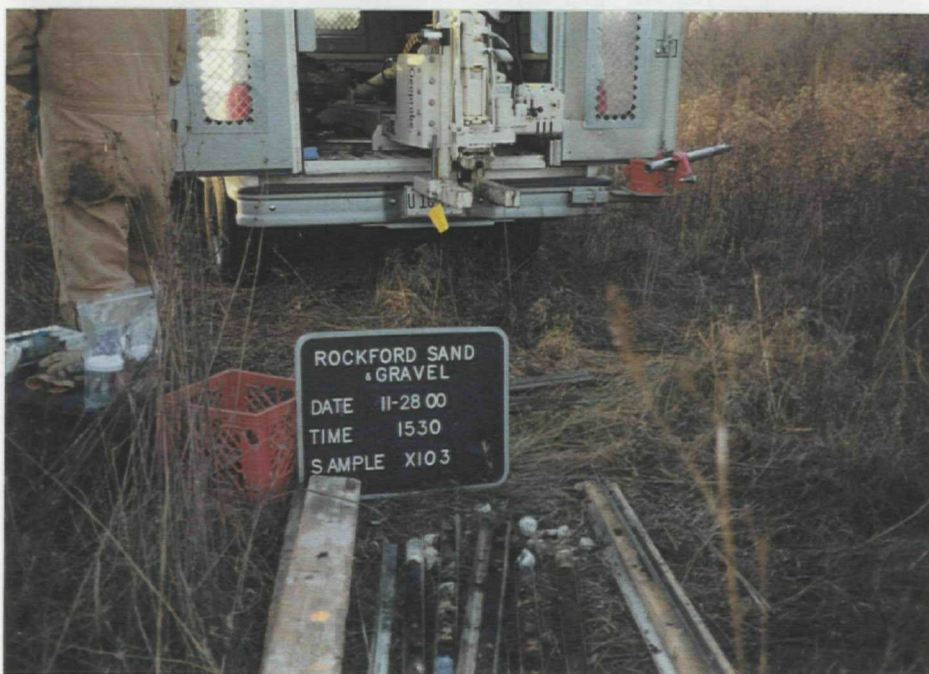
DATE: 11-28-2000
TIME: 15:30
PHOTOGRAPH TAKEN BY: R. CASPER
COMMENTS: Picture taken toward: South.
Photo Number 8.
Sample X103. The
sample was collect-
ed with the Geo-
Probe at a depth
of 16 to 20 feet.

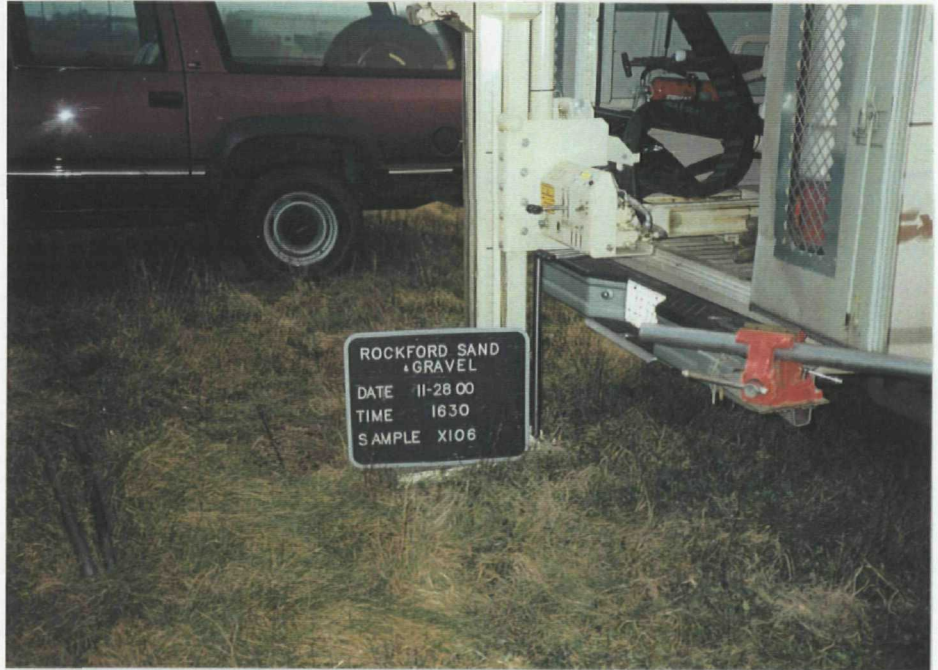
DATE: 11-28-2000	SITE ILO#: 000034371	COUNTY: Winnebago
TIME: 16:30	SITE NAME: Rockford Sand & Gravel	
PHOTOGRAPH TAKEN BY: R. Casper		
COMMENTS: Picture taken toward: South.		
Photo Number 9.		
Sample X106 was collected near the northwestern area of the property.

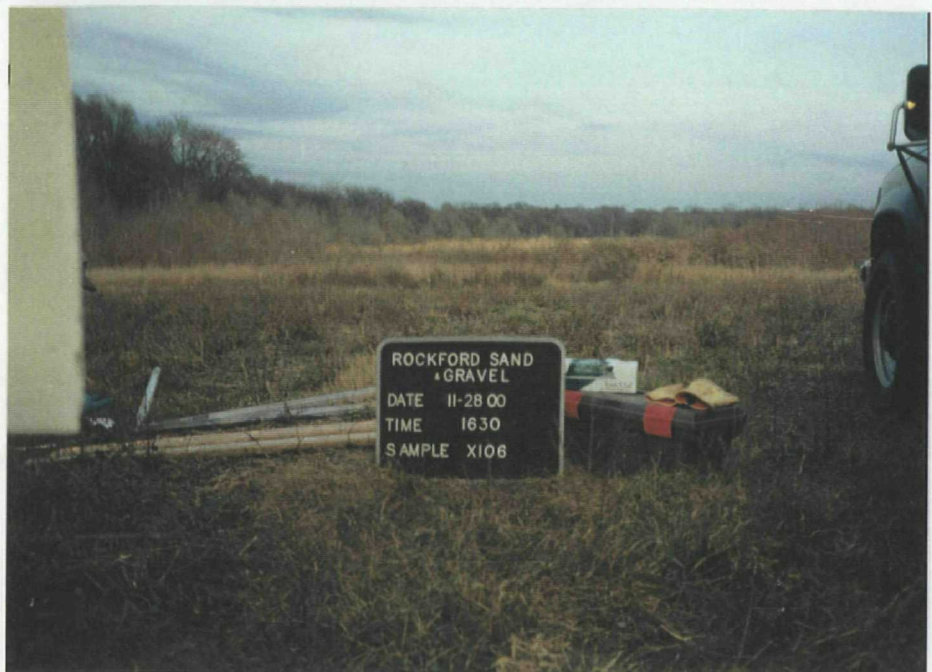
DATE: 11-28-2000
TIME: 16:30
PHOTOGRAPH TAKEN BY: R. CASPER
COMMENTS: Picture taken toward: East.
Photo Number 10.
Sample X106. The sample was collected with the Geo-Probe at a depth of 8 to 12 feet.

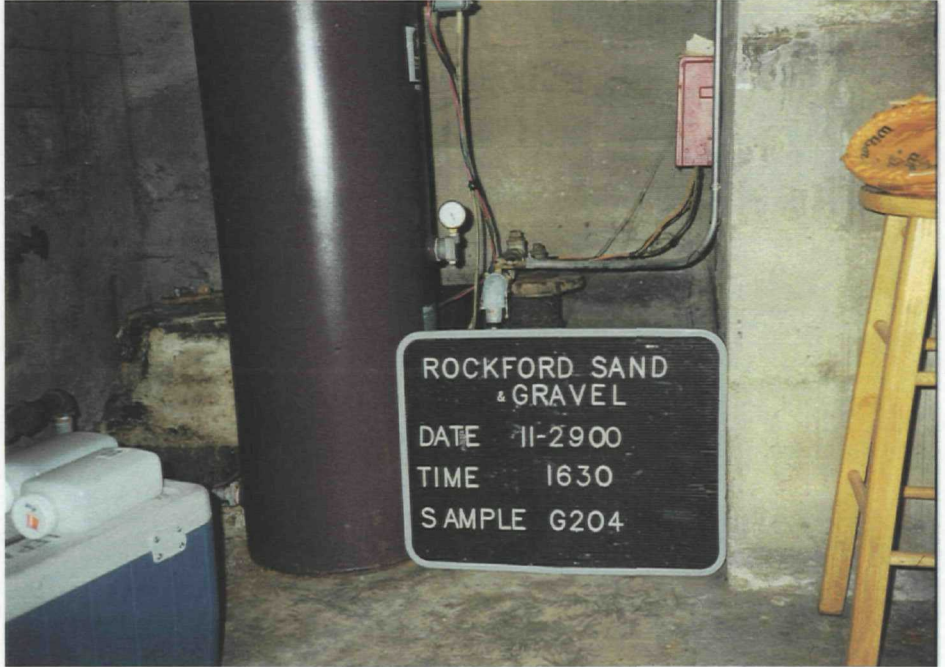
COMMENTS: Picture taken toward: West..		
Photo Number 11.		
Sample G204 was collected at a private residence west of the site.		
(Note: time on photo is incorrect)

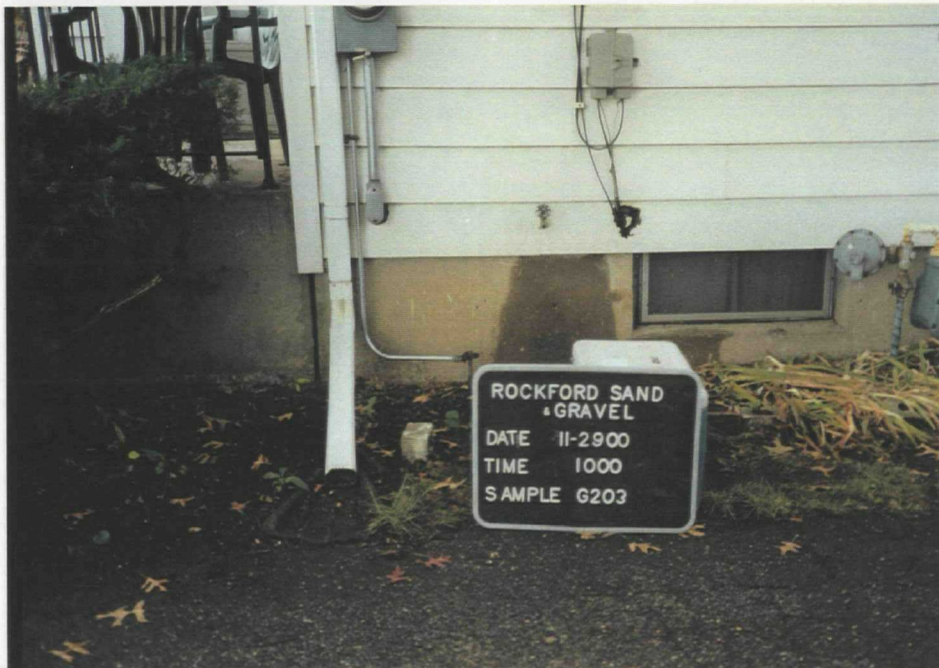
DATE: 11-29-2000	SITE ILO#: 000034371	COUNTY: Winnebago
TIME: 10:00	SITE NAME: Rockford Sand & Gravel	
PHOTOGRAPH TAKEN BY: R. Casper		
COMMENTS: Picture taken toward: West.		
Photo Number 12.		
Sample G203 was collected at a private residence located west of the site.

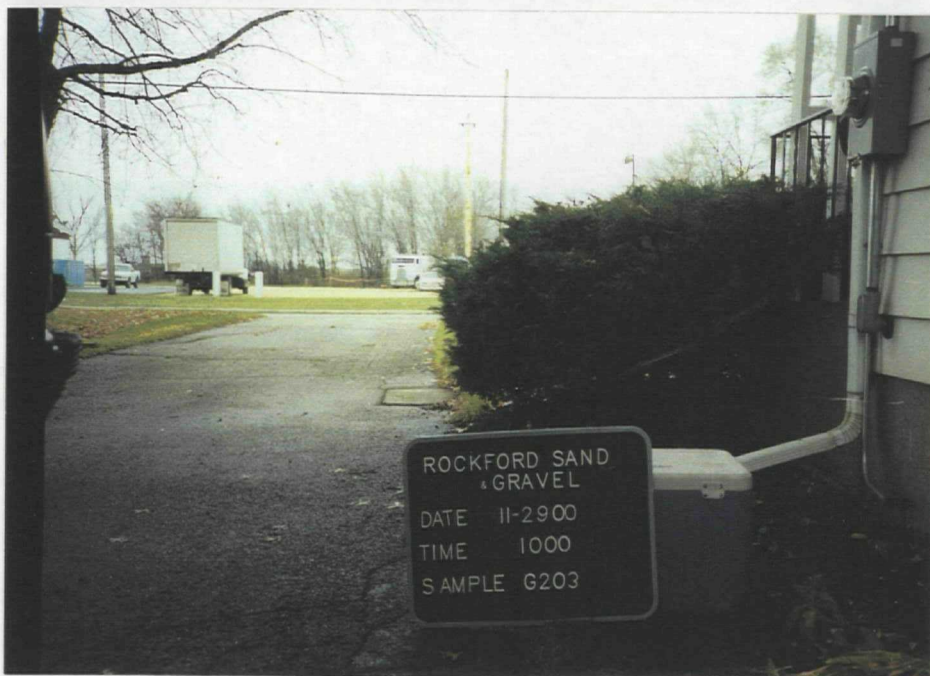
DATE: 11-29-2000
TIME: 10:00
PHOTOGRAPH TAKEN BY: R. CASPER
COMMENTS: Picture taken toward: South.
Photo Number 13.
Sample G203. The sample was collected from an outside tap after water parameters had stabilized.

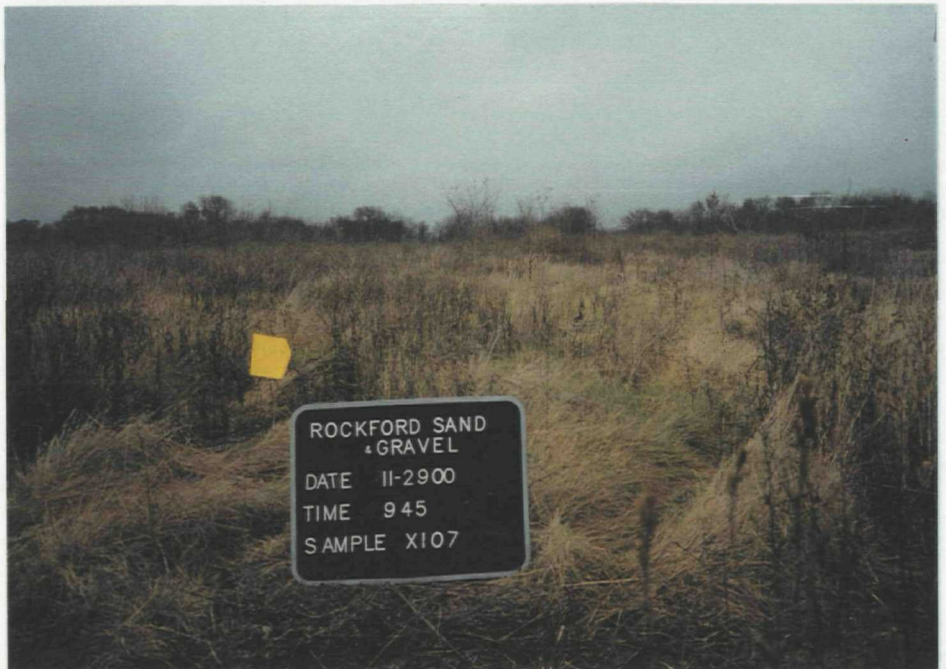
DATE: 11-29-2000	SITE ILO#: 000034371	COUNTY: Winnebago
TIME: 9:45	SITE NAME: Rockford Sand & Gravel	
PHOTOGRAPH TAKEN BY: R. Casper		
COMMENTS: Picture taken toward: North.		
Photo Number 14.		
Sample X107 was collected at the southwestern area of the property.

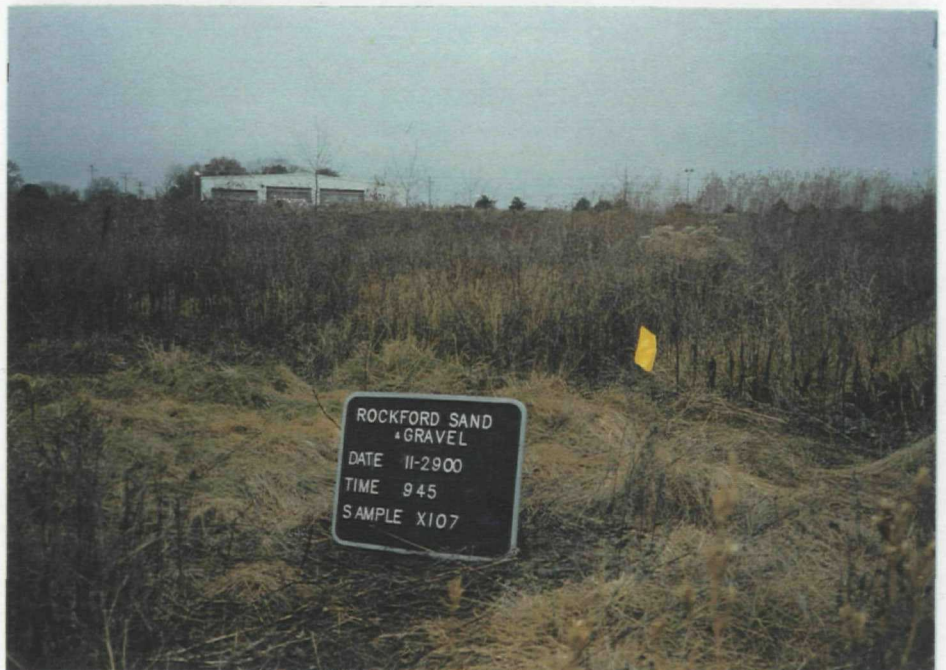
DATE: 11-29-2000
TIME: 9:45
PHOTOGRAPH TAKEN BY: R. CASPER
COMMENTS: Picture taken toward: South.
Photo Number 15.
Sample X107. The sample was collect-
ed at a depth of
6 to 8 feet.

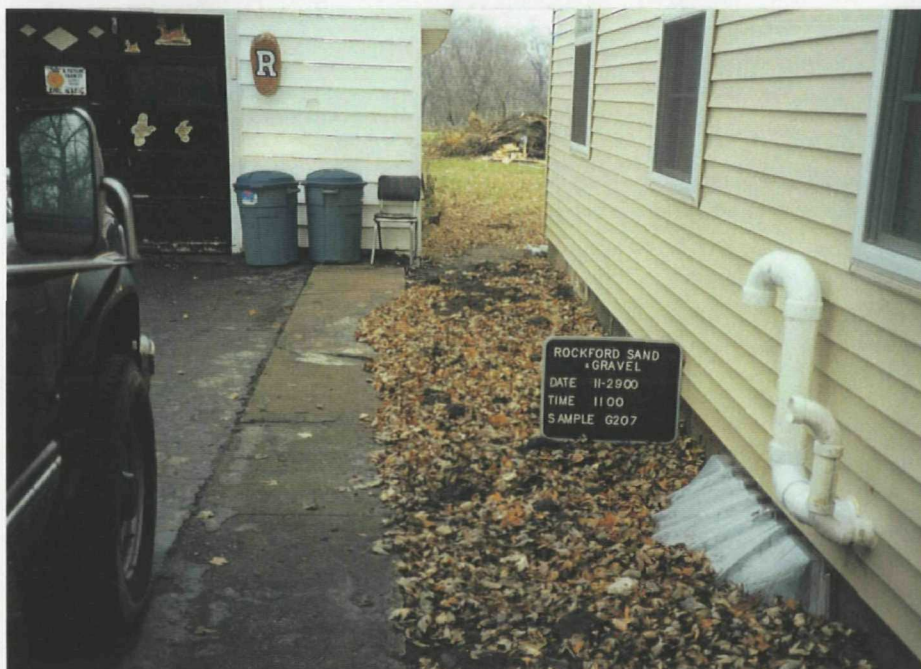
DATE: 11-29-2000	SITE ILO#: 000034371	COUNTY: Winnebago
TIME: 11:00	SITE NAME: Rockford Sand & Gravel	
PHOTOGRAPH TAKEN BY: R. Casper		
COMMENTS: Picture taken toward: East.		
Photo Number 16.		
Sample G207 was collected from a private residence located north of the site.

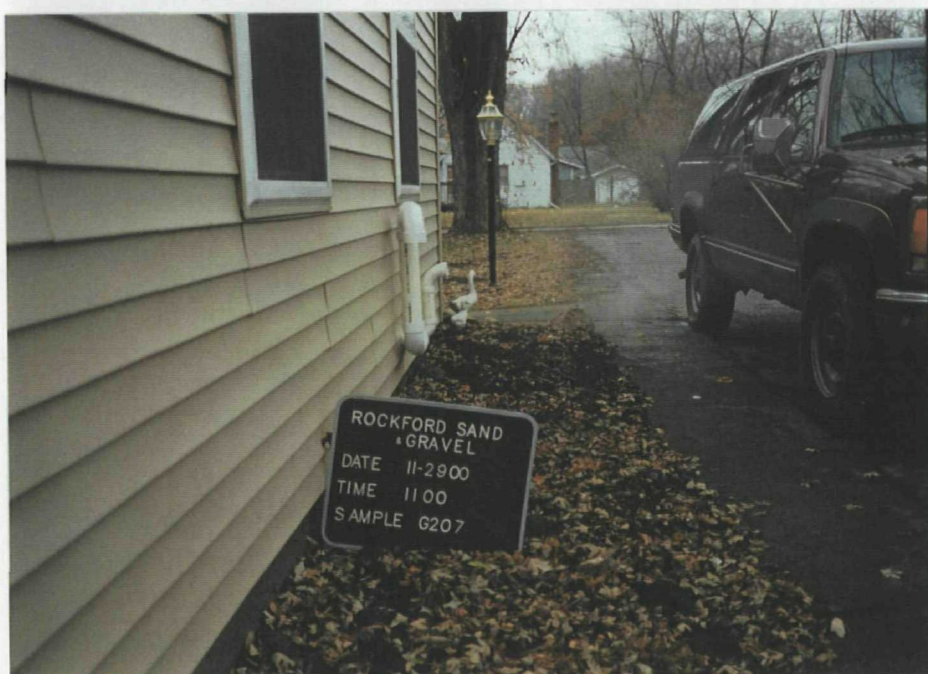
DATE: 11-29-2000
TIME: 11:00
PHOTOGRAPH TAKEN BY: R. CASPER
COMMENTS: Picture taken toward: West.
Photo Number 17.
Sample G207. The sample was collected from an outside tap after water parameters had stabilized.

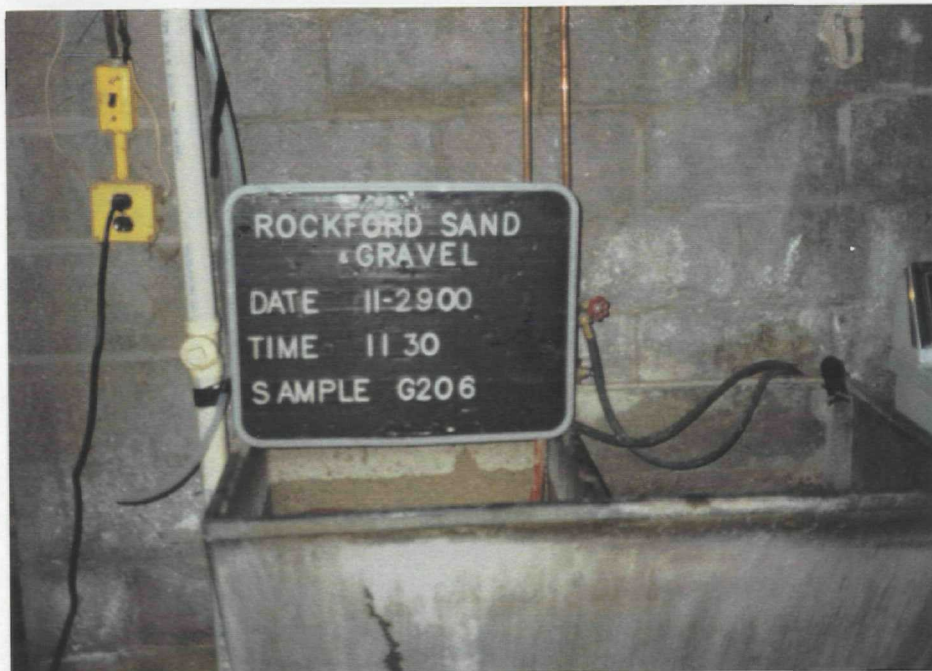
DATE: 11-29-2000	SITE ILO#: 000034371	COUNTY: Winnebago
TIME: 11:30	SITE NAME: Rockford Sand & Gravel	
PHOTOGRAPH TAKEN BY: R. Casper		
COMMENTS: Picture taken toward: South.		
Photo Number 18.		
Sample G206 was collected from an inside tap from a residence located north of the site.

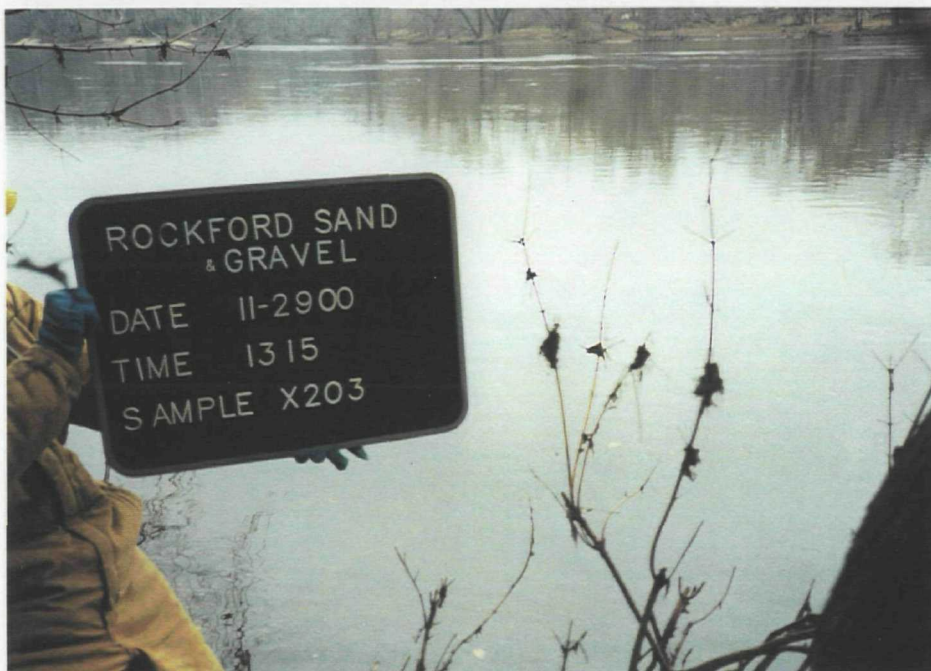
DATE: 11-29-2000	SITE ILO#: 000034371	COUNTY: Winnebago
TIME: 13:15	SITE NAME: Rockford Sand & Gravel	
PHOTOGRAPH TAKEN BY: R. Casper		
COMMENTS: Picture taken toward: North.		
Photo Number 20.		
Sediment sample		
X203 was collected		
from the east side		
of the property in		
the Rock River.

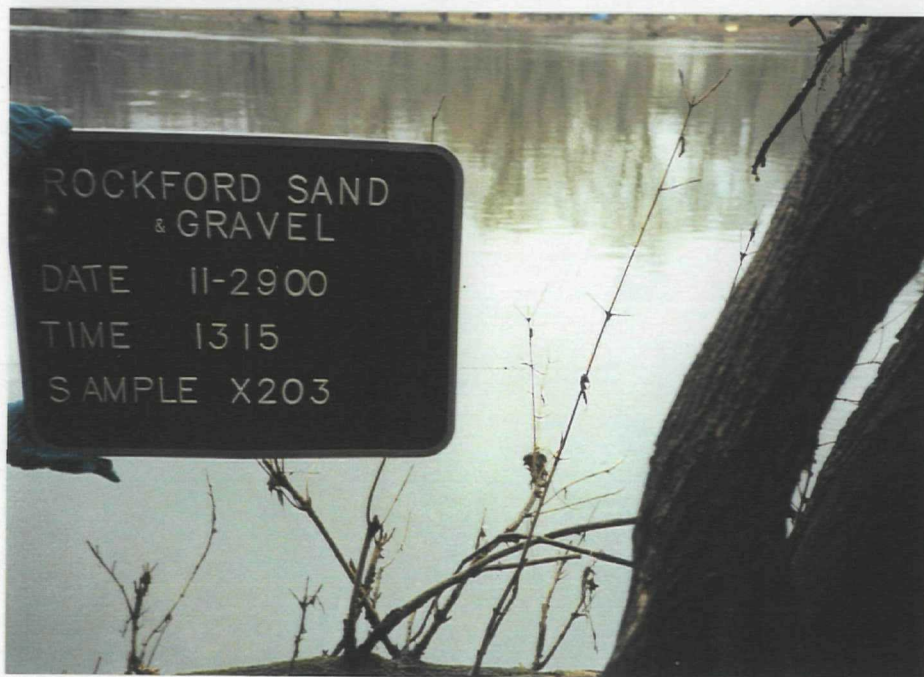
DATE: 11-29-2000
TIME: 13:15
PHOTOGRAPH TAKEN BY: R. CASPER
COMMENTS: Picture taken toward: South.
Photo Number 21.
Sample X203. The
sample consisted
of sand, gravel
and some silt col-
lected at a depth
of 1 to 8 inches.

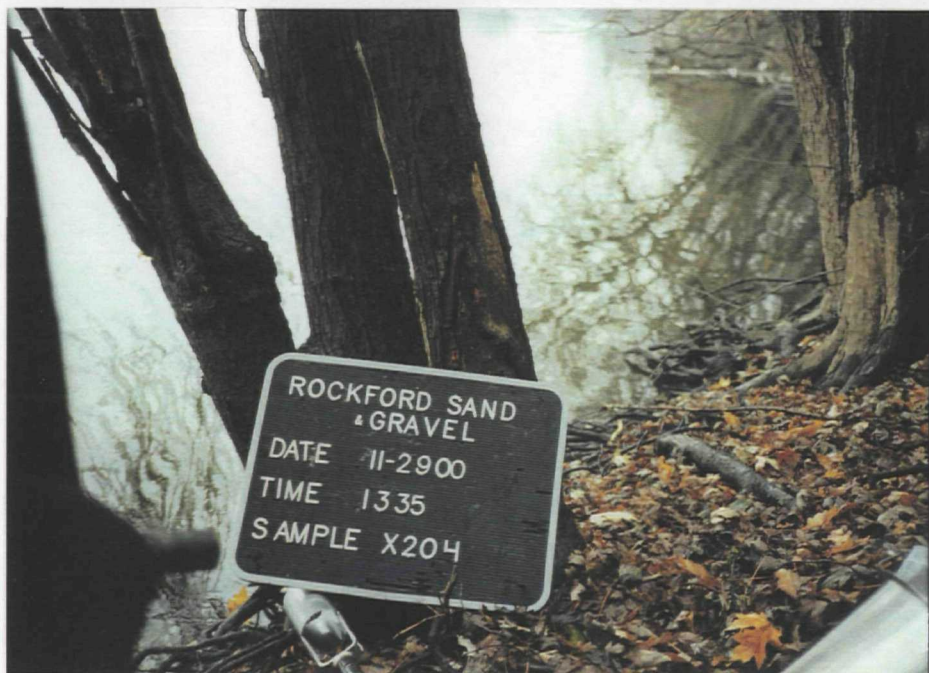
DATE: 11-29-2000	SITE ILO#: 000034371	COUNTY: Winnebago
TIME: 13:35	SITE NAME: Rockford Sand & Gravel	
PHOTOGRAPH TAKEN BY: R. Casper		
COMMENTS: Picture taken toward: South.		
Photo Number 22.		
Sediment sample		
X204 was collected from the east side of the property in the Rock River.

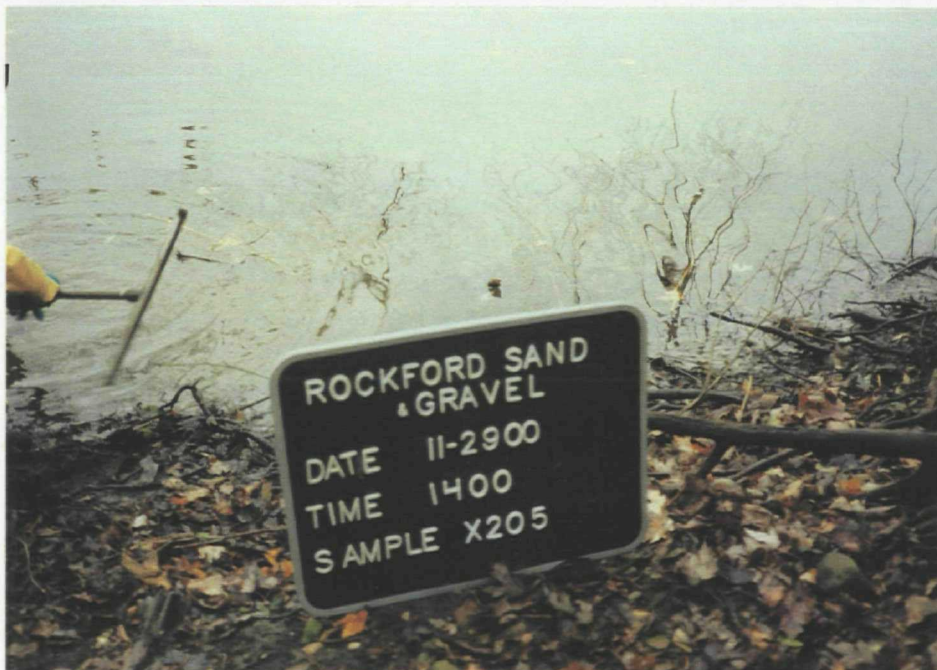
DATE: 11-29-2000	SITE ILO#: 000034371	COUNTY: Winnebago
TIME: 14:00	SITE NAME: Rockford Sand & Gravel	
PHOTOGRAPH TAKEN BY: R. Casper		
COMMENTS: Picture taken toward: East.		
Photo Number 24.		
Sediment sample		
X205 was collected		
from the east side		
of the property in		
the Rock River.

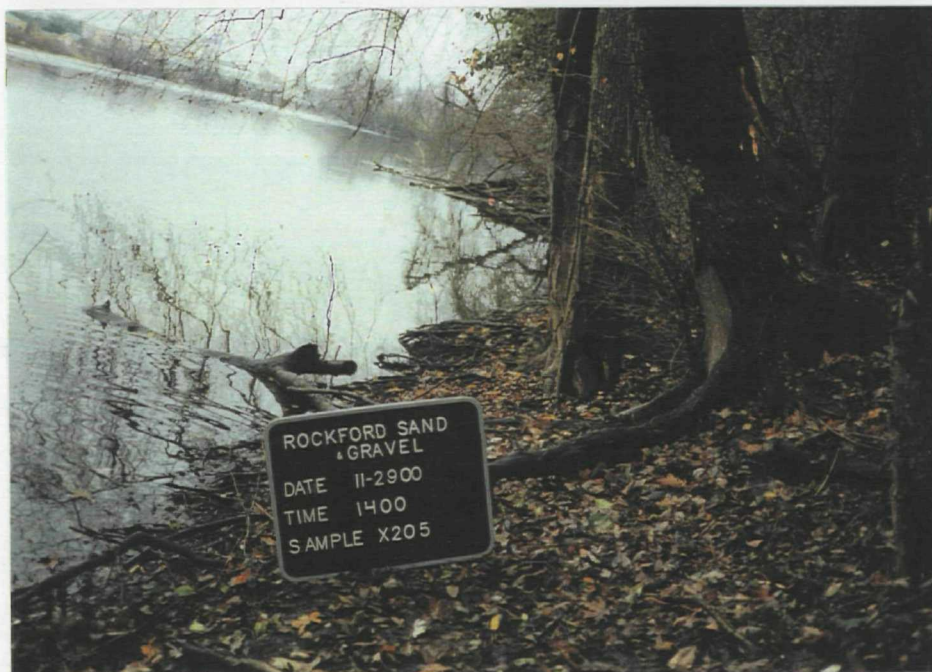
DATE: 11-29-2000
TIME: 14:00
PHOTOGRAPH TAKEN BY: R. CASPER
COMMENTS: Picture taken toward: South.
Photo Number 25.
Sample X205. The
sample consisted
of black silt with
organic matter col-
lected at a depth
of 1 to 8 inches.

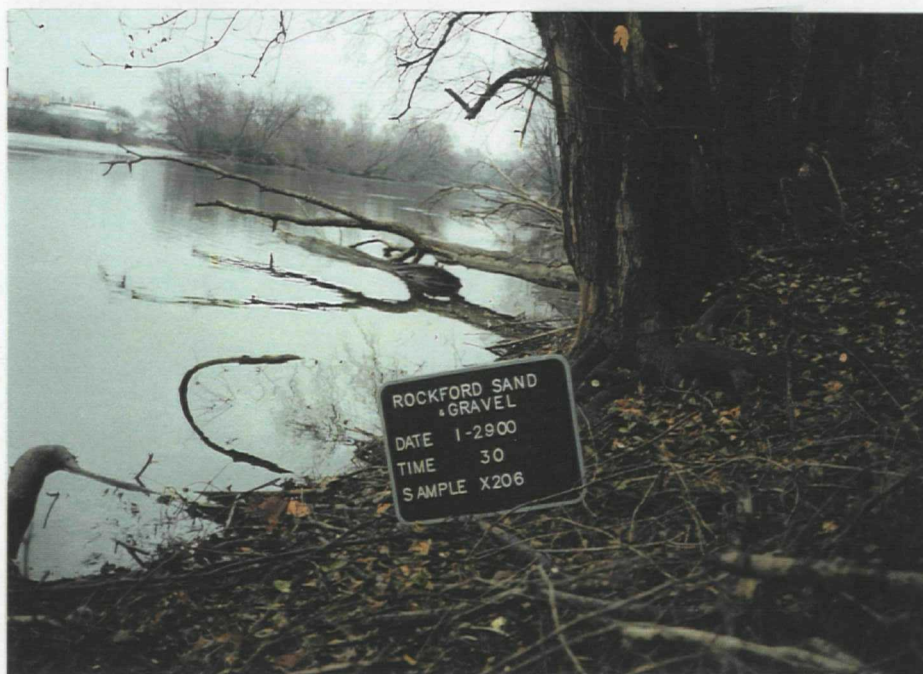
DATE: 11-29-2000
TIME: 14:30
PHOTOGRAPH TAKEN BY: R. CASPER
COMMENTS: Picture taken toward: South.
Photo Number 27.
Sample X206. The
sample consisted
of black silt with
organic matter col-
lected at a depth
of 1 to 8 inches.

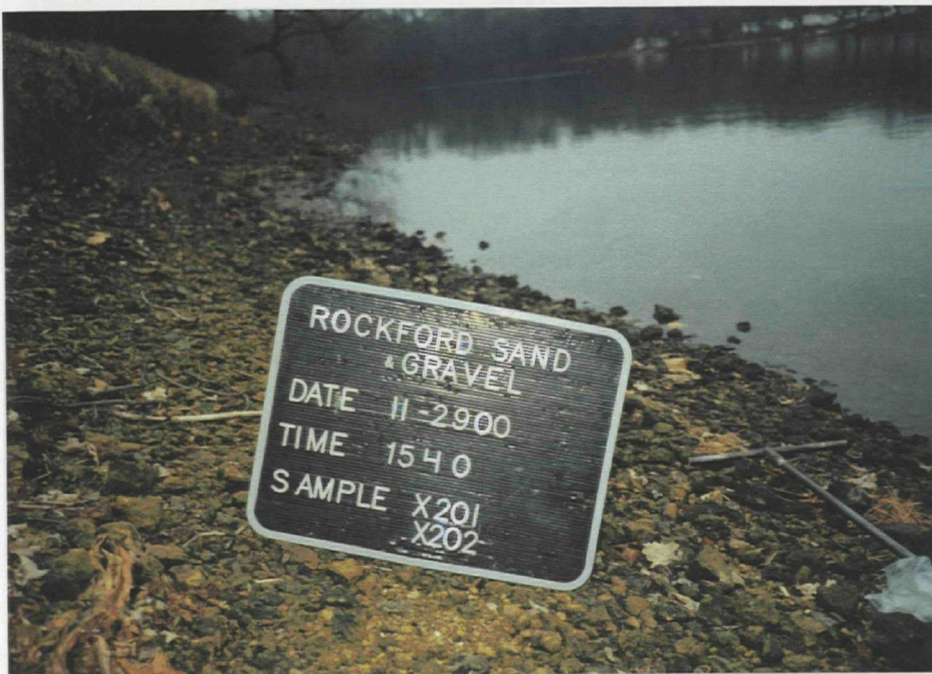
DATE: 11-29-2000	SITE ILO#: 000034371	COUNTY: Winnebago
TIME: 15:40	SITE NAME: Rockford Sand & Gravel	
PHOTOGRAPH TAKEN BY: R. Casper		
COMMENTS: Picture taken toward: South.		
Photo Number 30.		
Sediment sample		
X201/X202 is a		
background and		
duplicate sample.

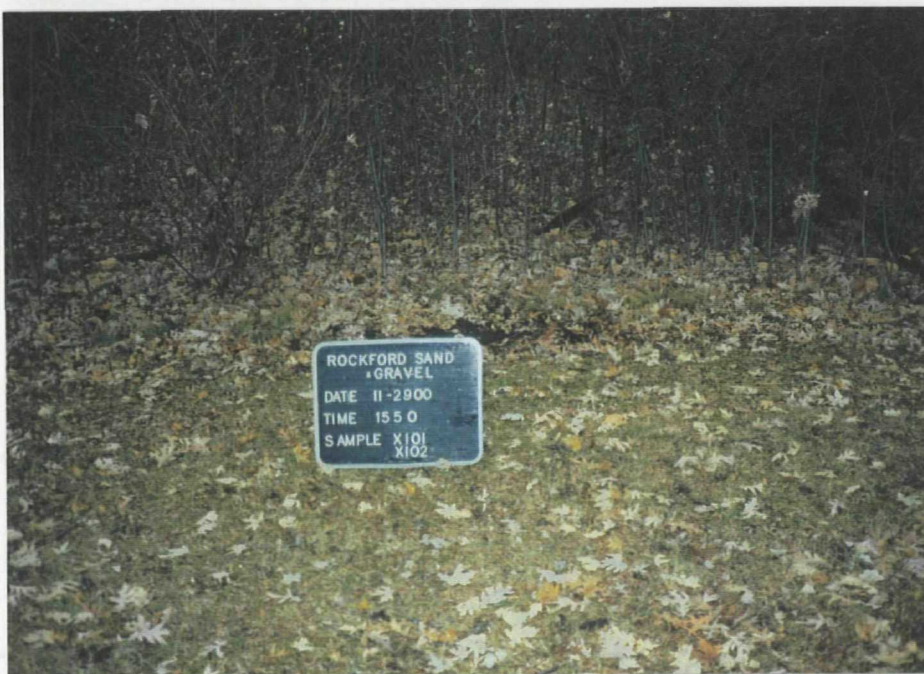
DATE: 11-29-2000	SITE ILO#: 000034371	COUNTY: Winnebago
TIME: 15:50	SITE NAME: Rockford Sand & Gravel	
PHOTOGRAPH TAKEN BY: R. Casper		
COMMENTS: Picture taken toward: East.		
Photo Number 32.		
Soil sample		
X101/X102 is a		
background and		
duplicate sample.

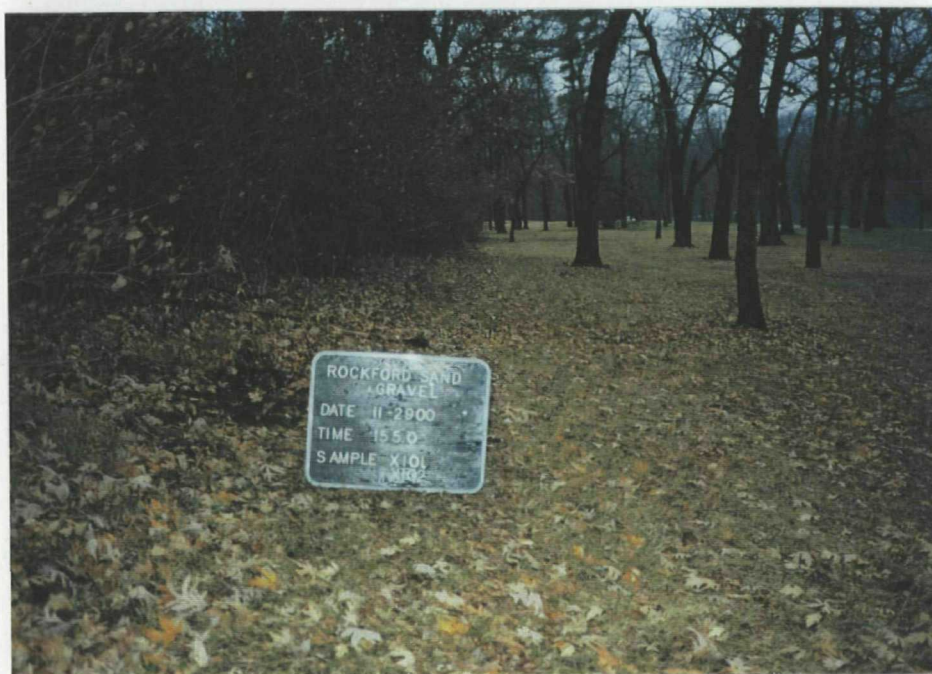
DATE: 11-29-2000
TIME: 15:50
PHOTOGRAPH TAKEN BY: R. CASPER
COMMENTS: Picture taken toward: South.
Photo Number 33.
Sample X101/X102.
The sample was
collected from
Blackhawk Park,
located approx. 1.4
miles north of site
